Rainbow Gathering 2008 Cleanup Report (short)

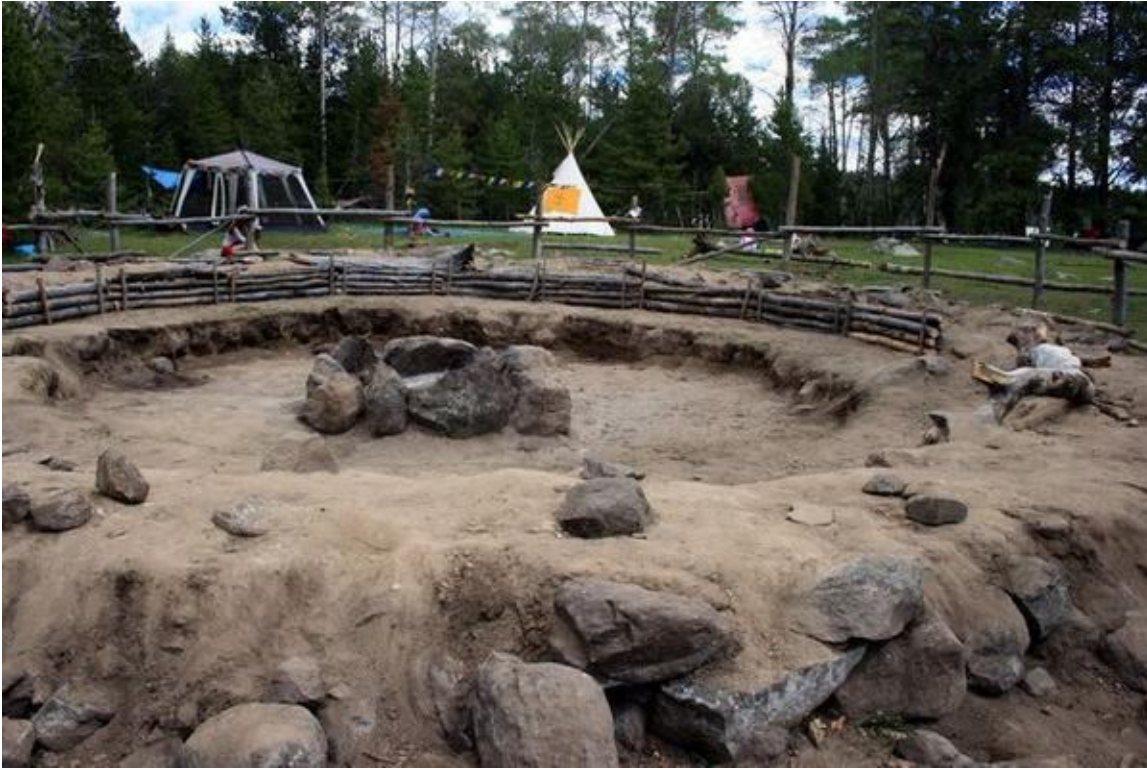
The photo below shows the main boogie pit during the gathering. The boulders used in its construction were removed from the hole that was dug and returned there during our rehabilitation process.

In regards to the one large fire pit that some people complained about, most of the construction was mud covered wood and rocks resting upon the ground. We along with the USFS measured the actual hole to be 1' 6" to about 1'8" deep and approximately 18 feet in diameter. The next level up was the meadow itself and not a hole. Then above that area was a stack of logs covered in mud with a railing for safety purposes. The area of the fire itself was approximately 6 feet in diameter including the boulders.

As clearly illustrated in the photo below, the lower railing is a built up back rest on the meadow. Everything else is local rocks and or logs set on the meadow and covered in mud. The rock circle in the very center is the area of the actual fire. The space around it was for safety.

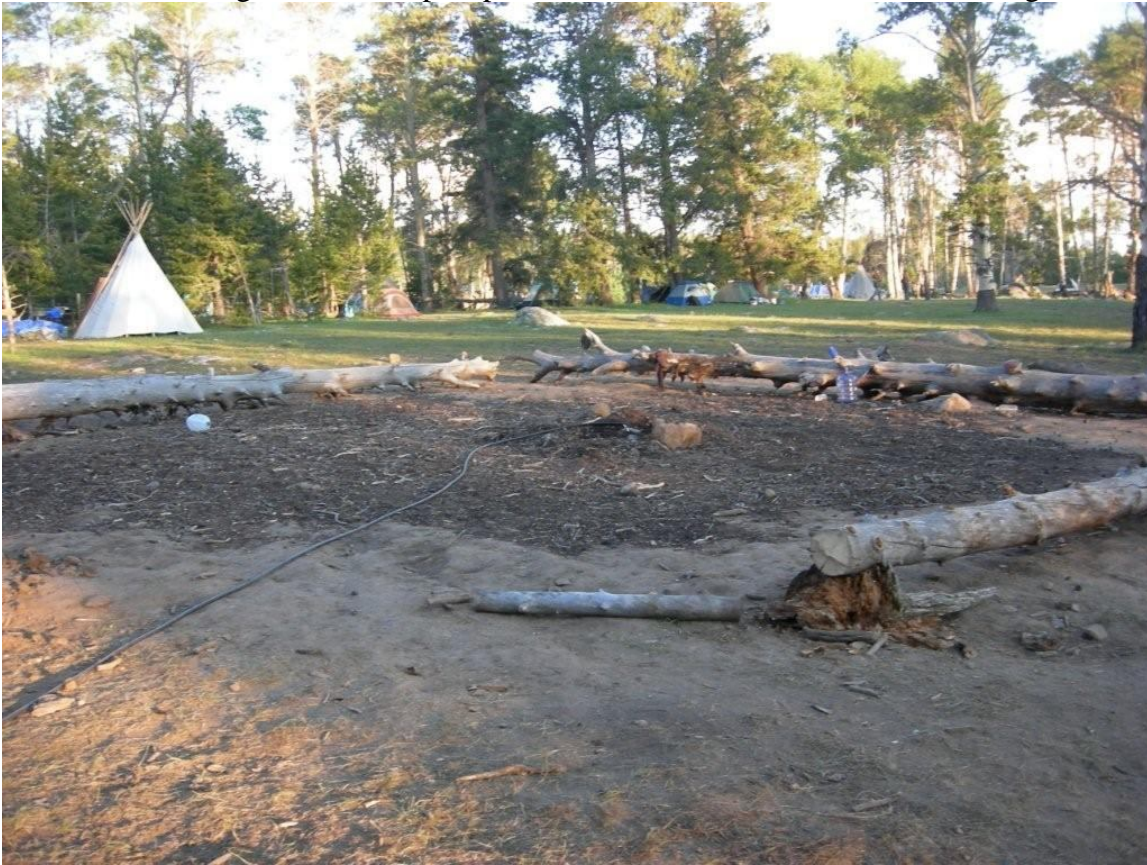
The photo below shows the same pit on the evening of July 7th during our rehabilitation process. Water is being used to dampen the area – thus encouraging root growth and helping settle the soil as part of the rehabilitation process.

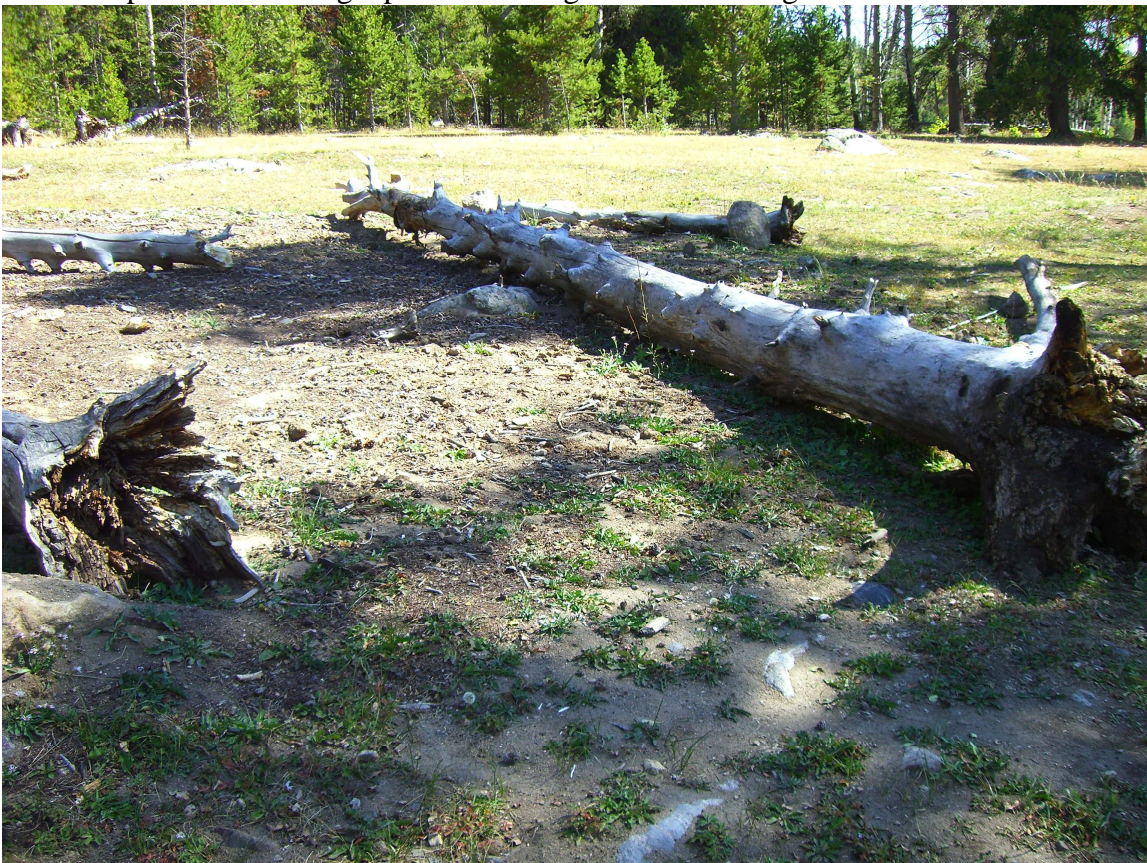
This first photo of the boogie pit is from August – notice the green

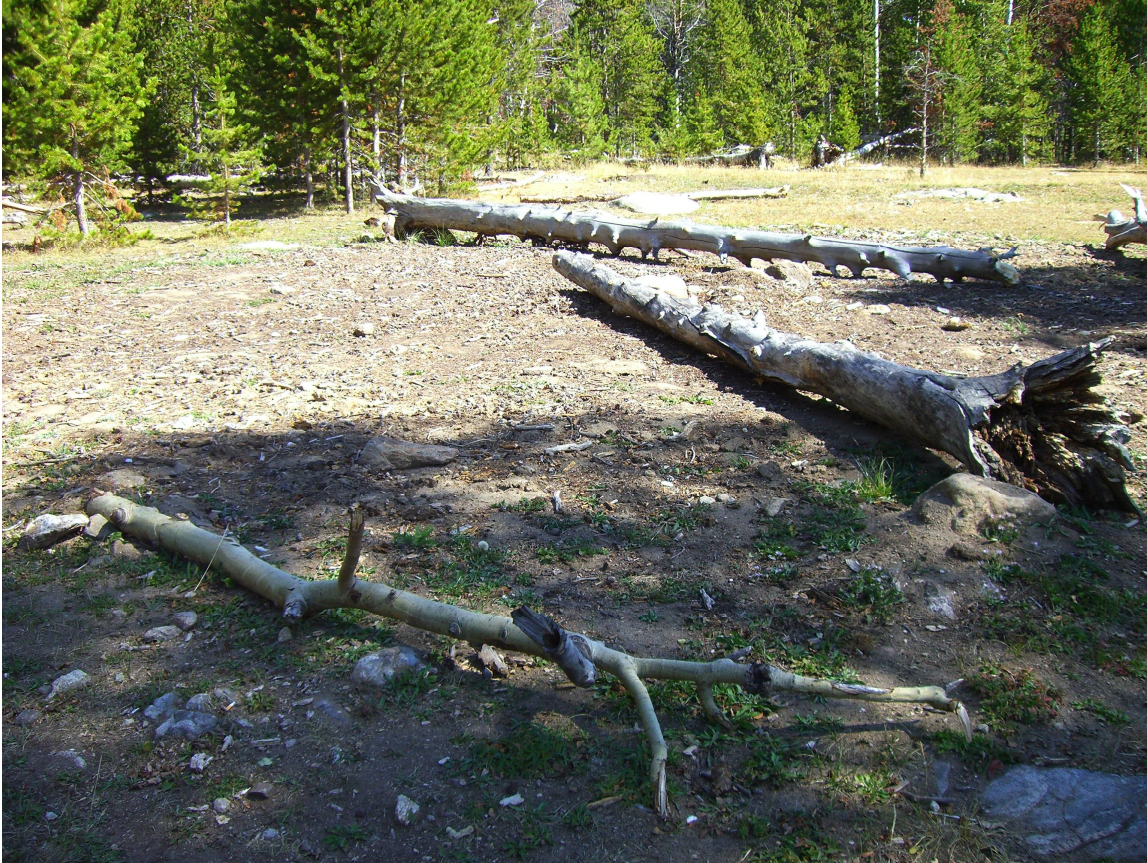
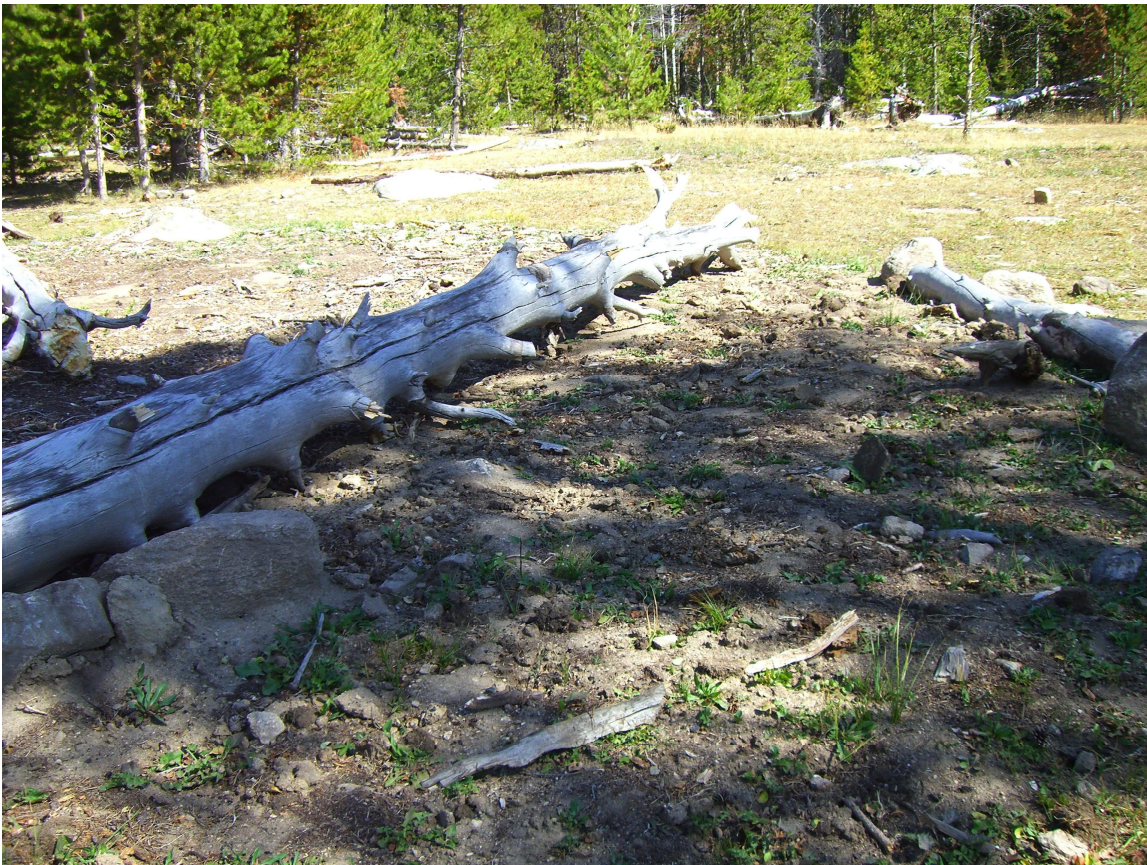
These next two photos were taken on September 16 – notice the plants growing in spite of the drought

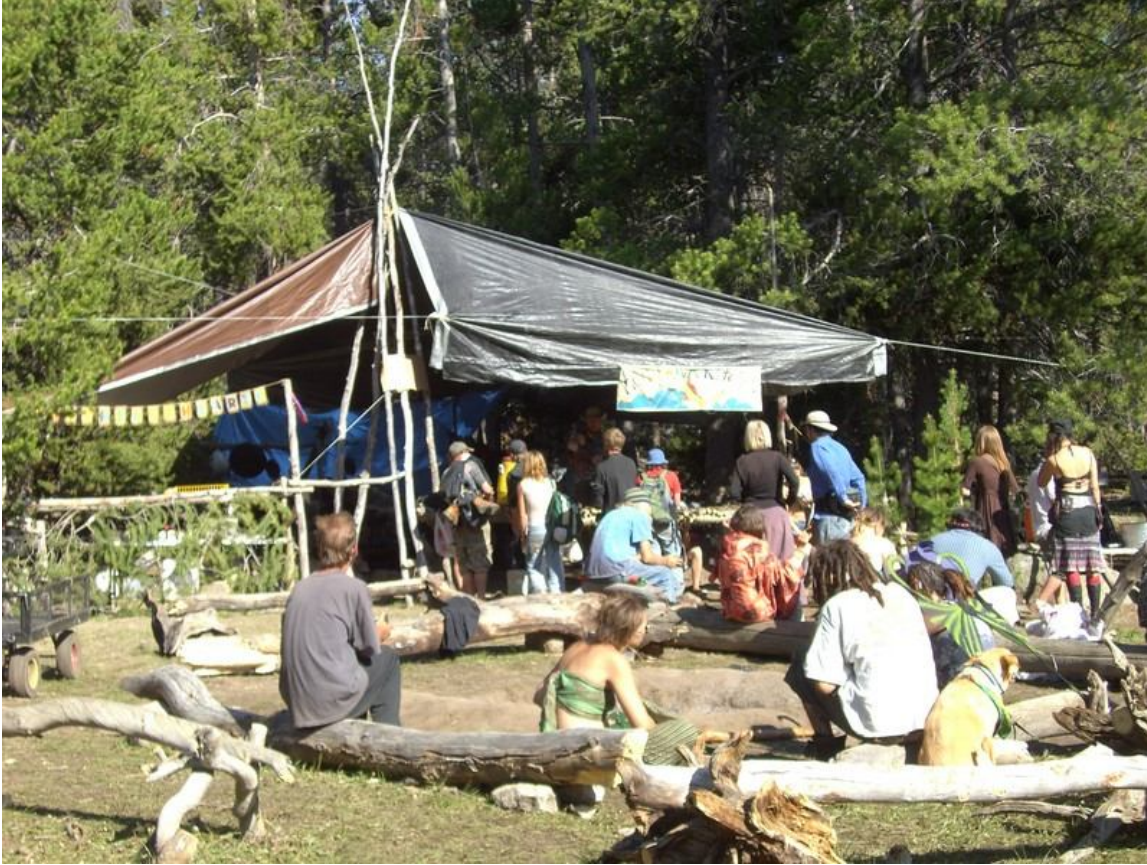
A Kitchen Rehabilitation

These during and after pictures of the large kitchen show the contrast between a fully functioning kitchen and the same spot after rehabilitation work has been done. The first photo was taken during the Gathering

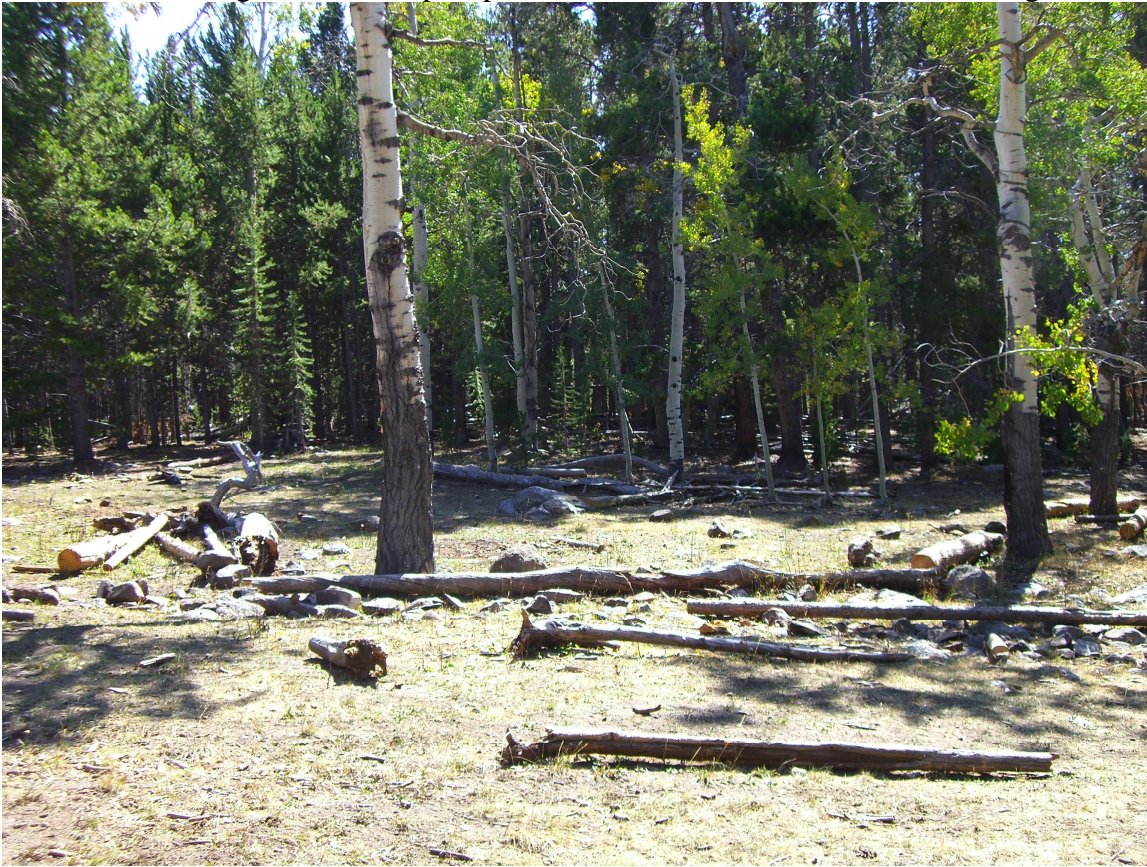
The photo below shows the same kitchen after cleanup

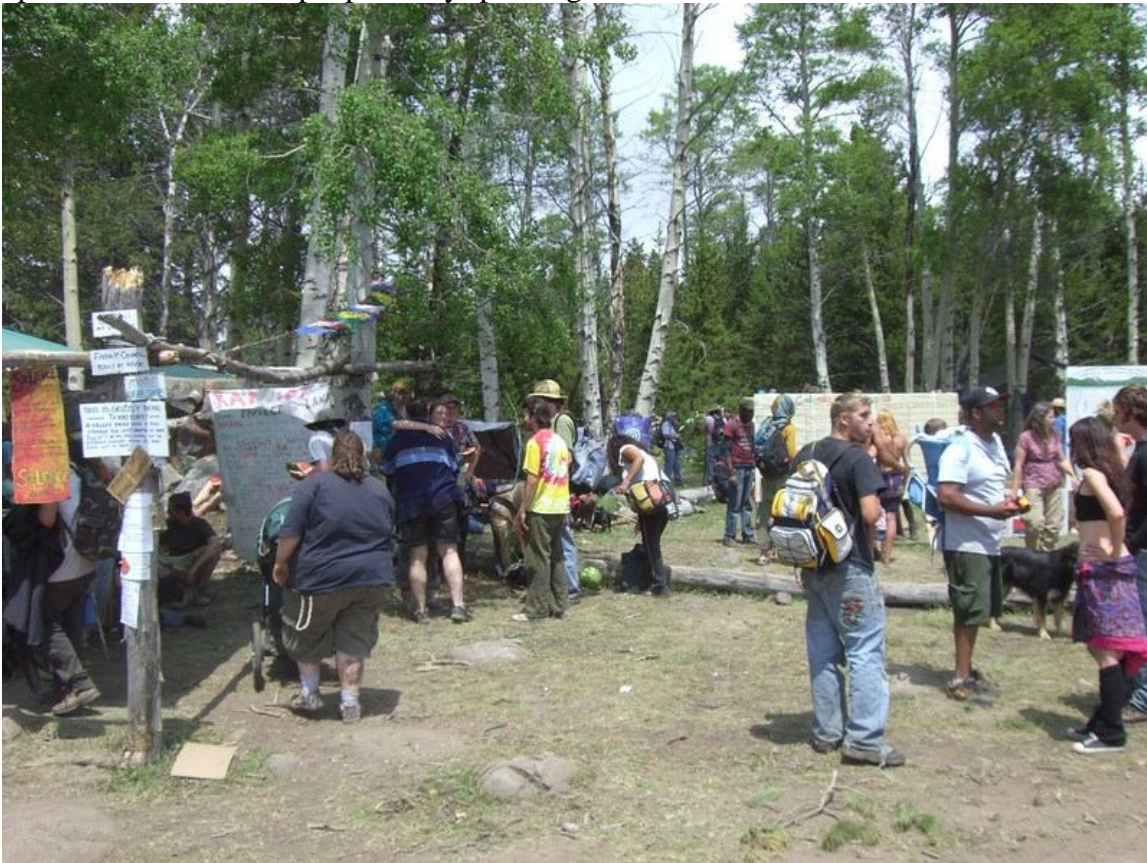
The Info Booth

The photo below shows the Info booth during the Gathering, which is visited non-stop during the gathering – upwards of a thousand people a day spending time here and is one of the main hubs of the gathering.

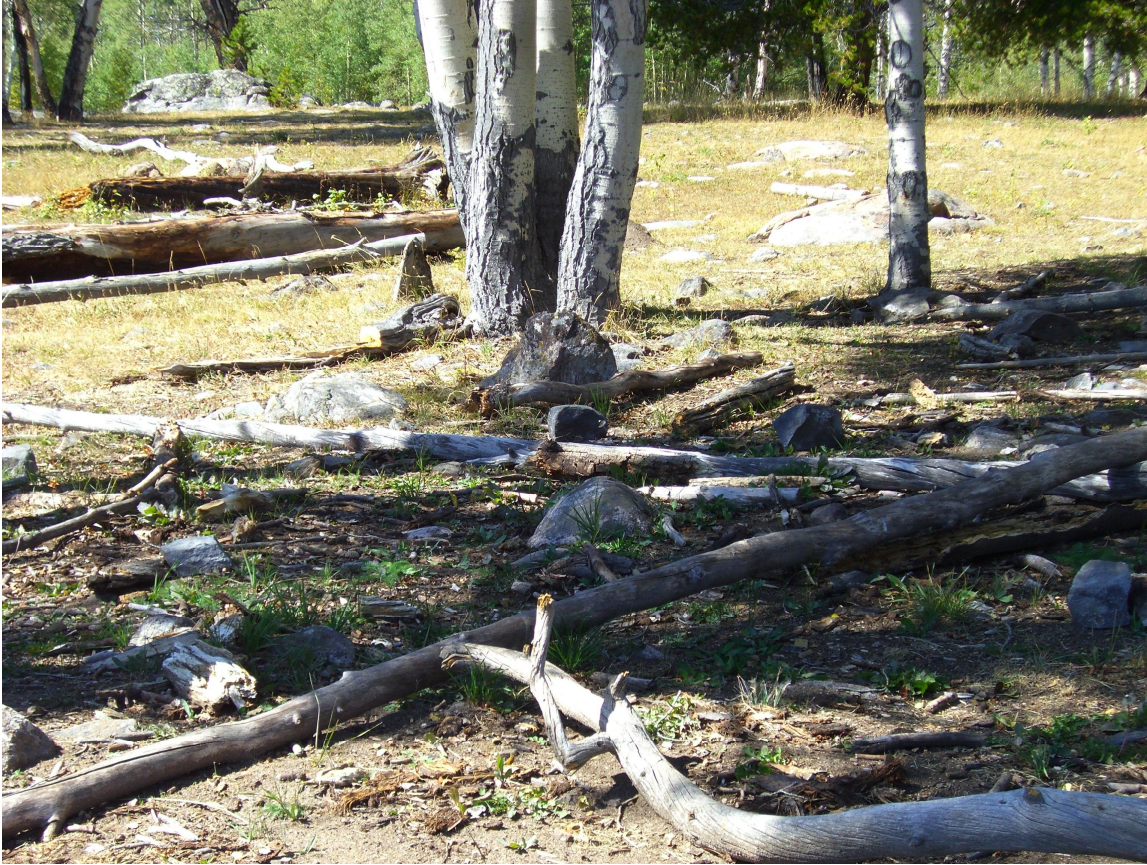
The photo below shows the Info Booth area at the end of cleanup.

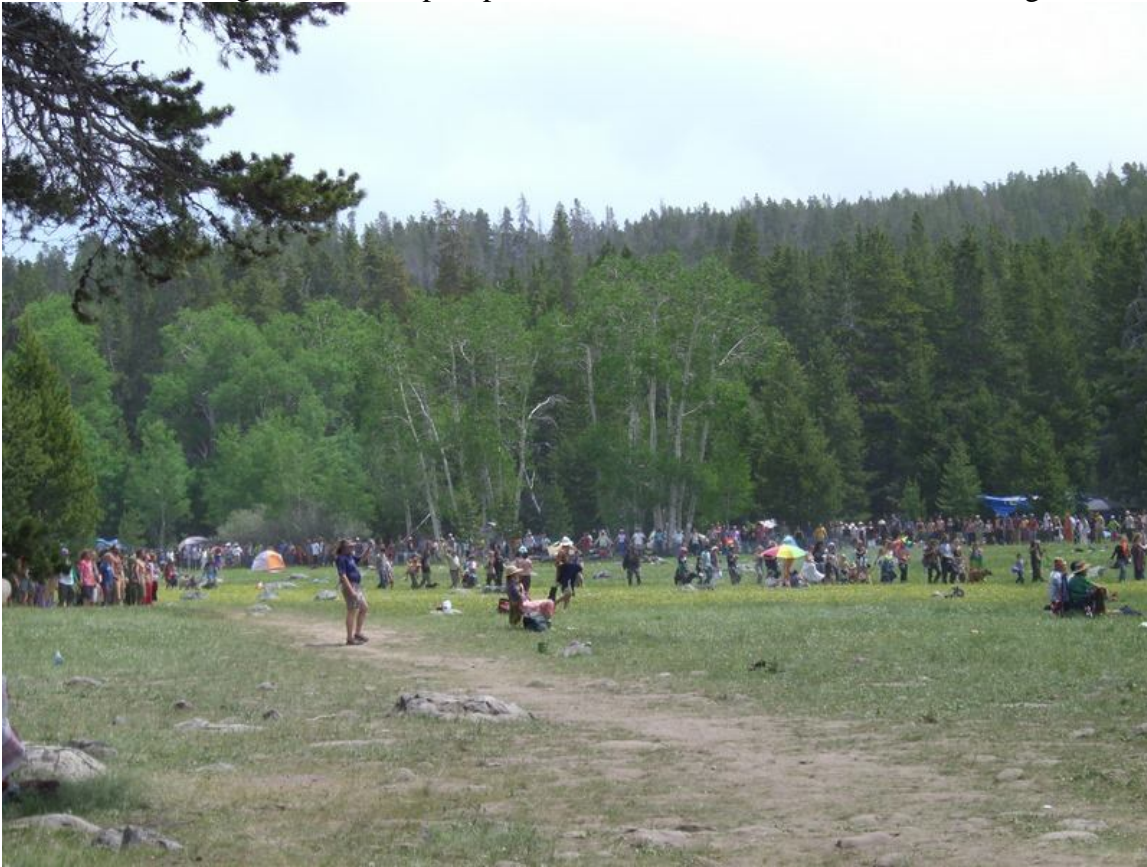
Trail to Kid Village

The photo below shows the heavily used trail to kid village during the gathering

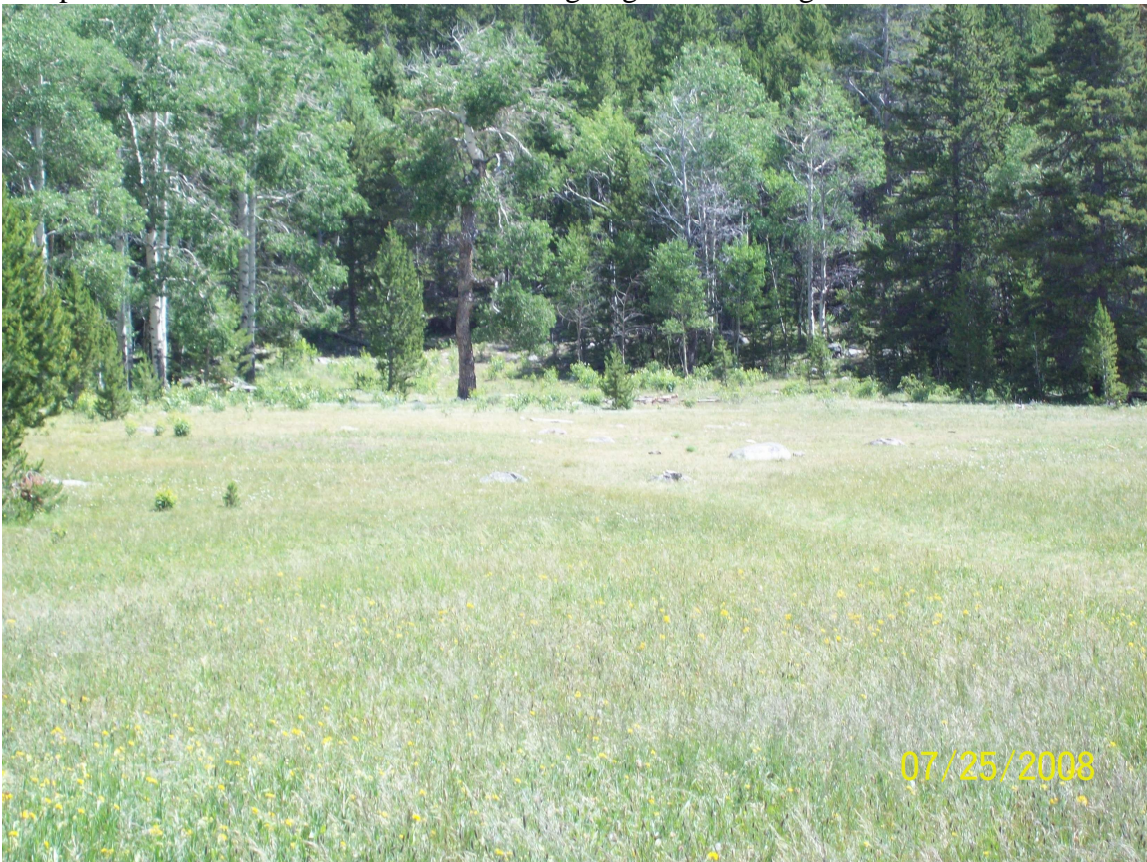
The photo below shows a shot of same trail going to Kid Village and was taken in late August/Early September.

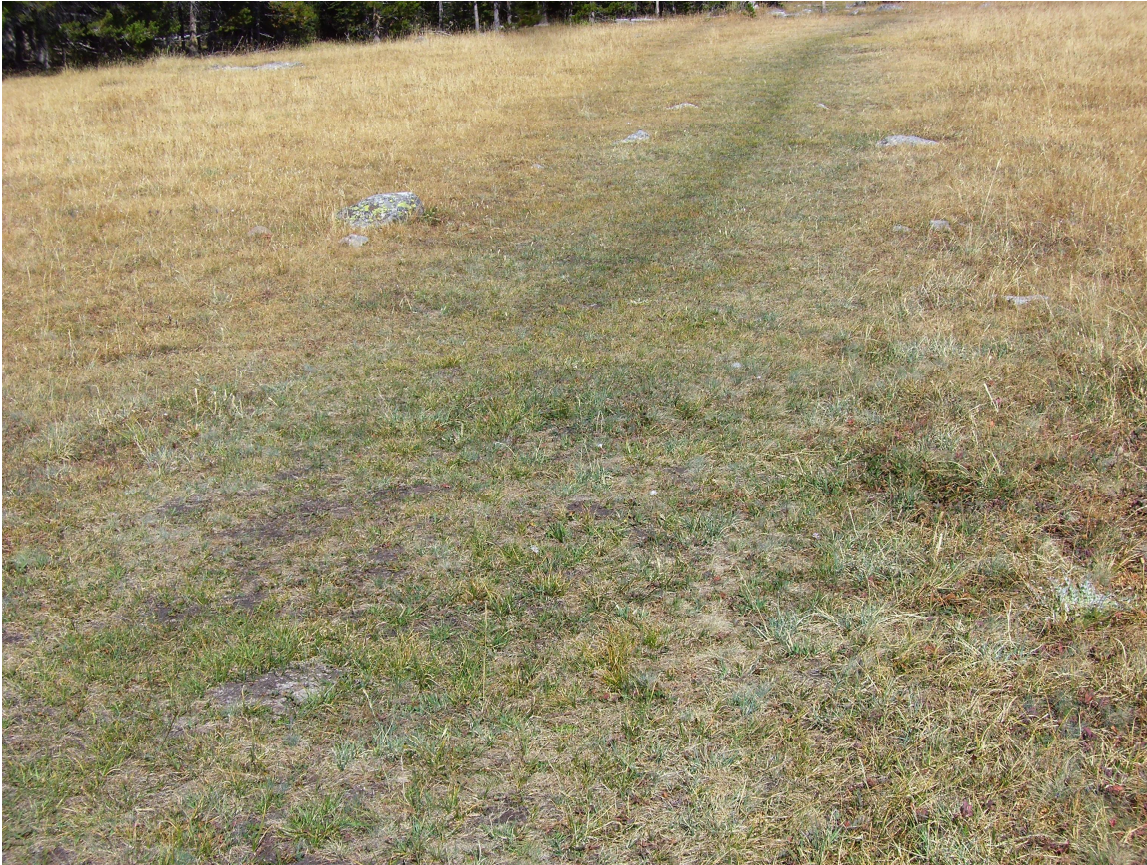
The photo below shows a close up of the trail to Kid Village after cleanup, photo taken in late August/early September. Notice that grass is growing where the trail was due to our rehabilitation efforts and the sides of the trail are yellow where we did not walk on the grass.

What seems to be heavy compaction on the trails, is really a thin crust of short term hard pack on top of the soil. Every year, I explain to the local resource people that under this crust is a damp soil. When the sun heats up the outer layer dries and cracks. Then the grass and other plant life grows in these cracks. The morning dew, which collects in the cracks, provides a water source. This process is evident in the photos included below.

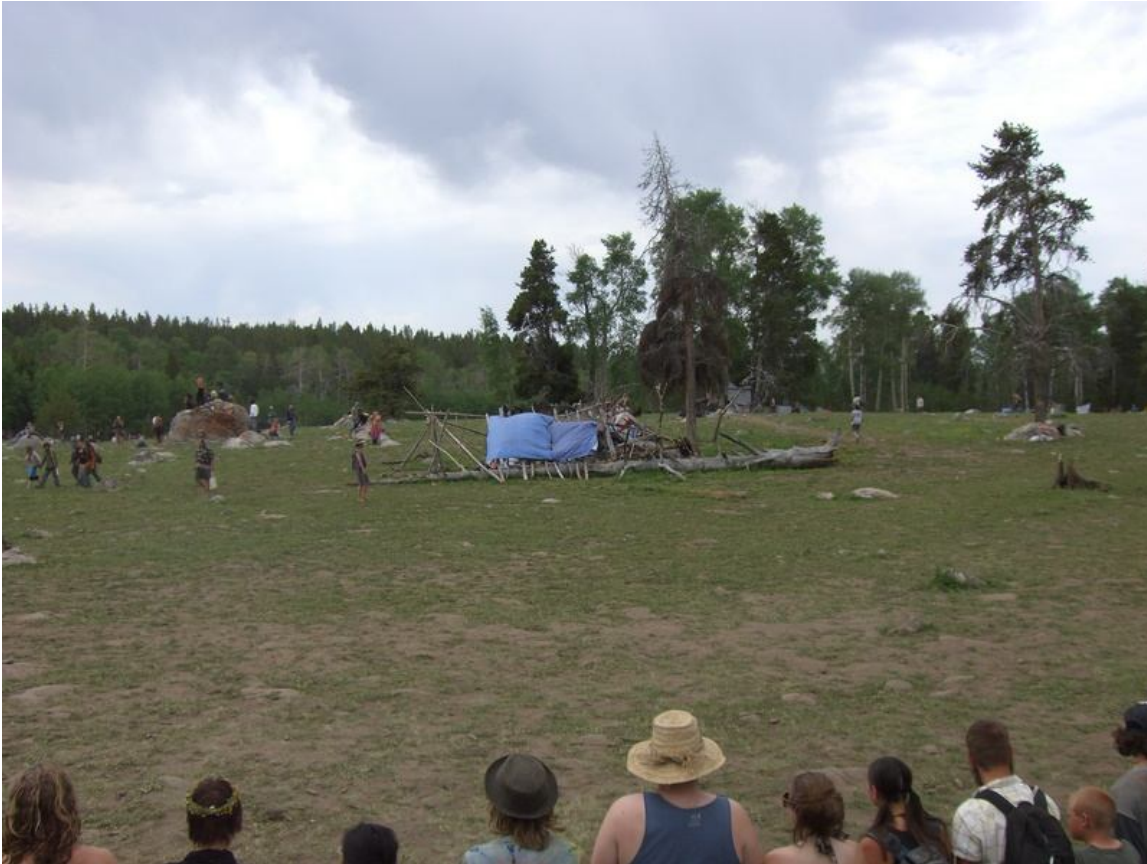
Main Meadow

The photo below shows what was our main meadow on July 4th during the prayer for world peace and shows the large rock and down trees in the meadow.

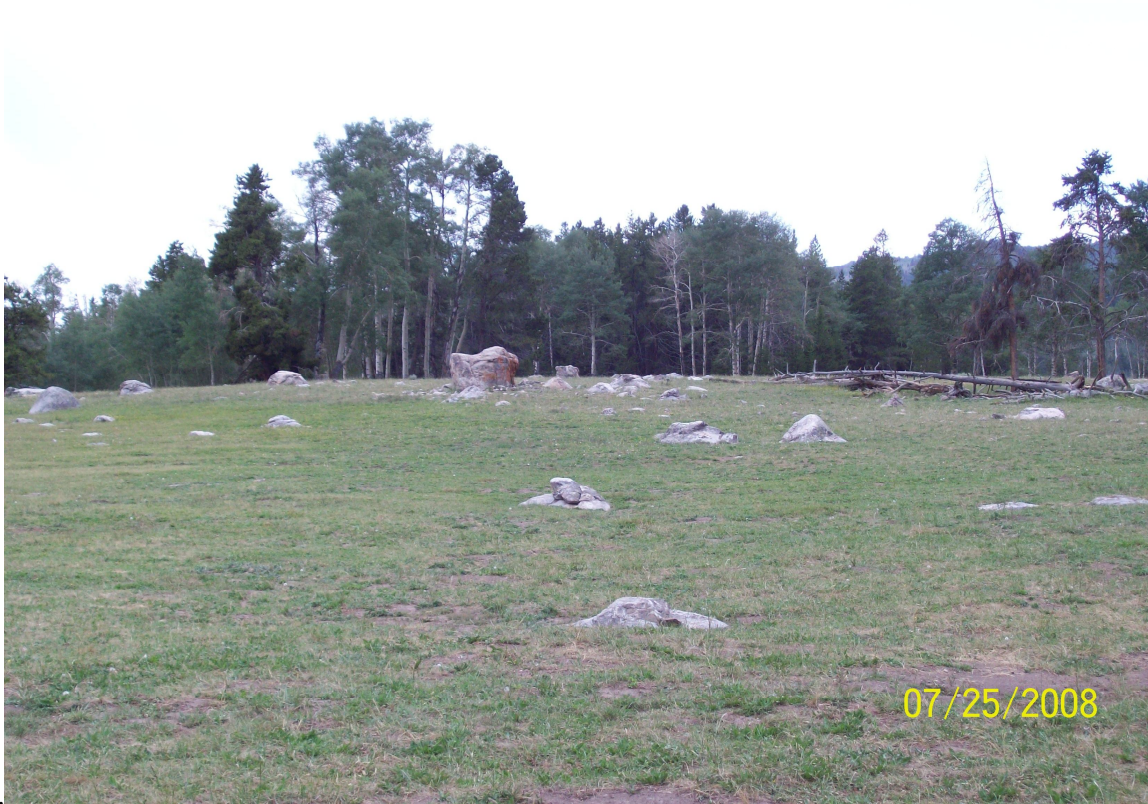
This next photo shows the same shot of main meadow after the gathering was over – this area was one of the most heavily used areas of the gathering. (The area that was in front of Info). Photo taken in August.

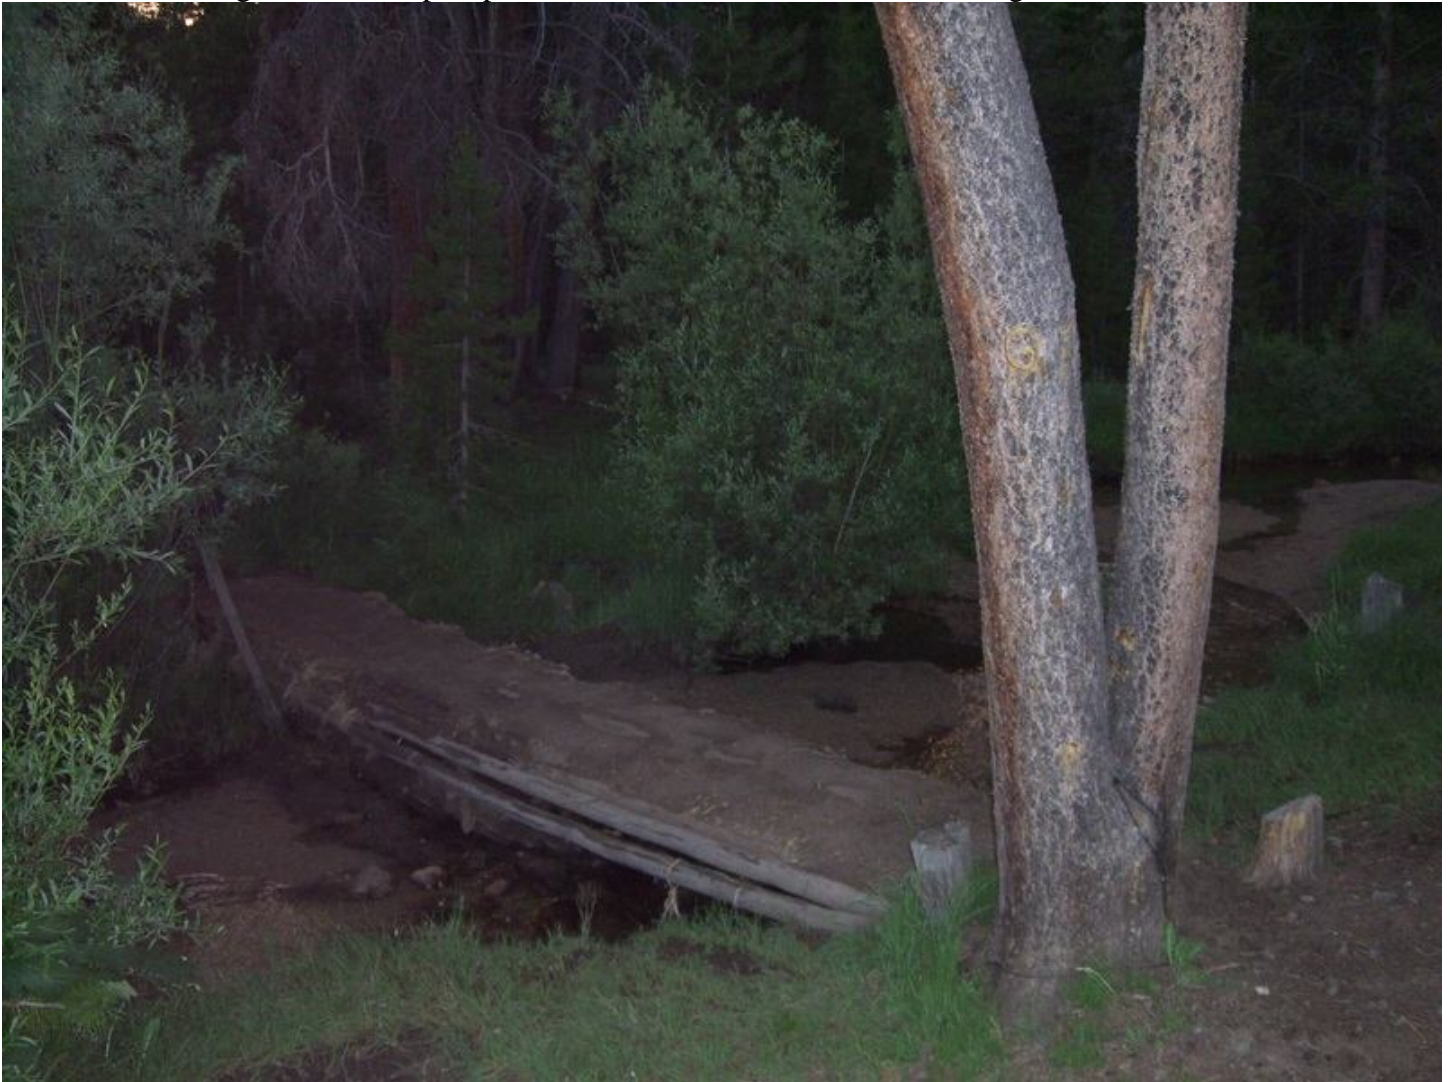
The Bridge at HandiCamp

The photo below shows the bridge improvements.

A small bridge existed at this location before the gathering started. We enhanced the bridge for safety reasons and to allow handicapped access. We were told to tear it down, which we did. However, locals rebuilt a bridge in mid-September at this same location after we removed the existing bridge.

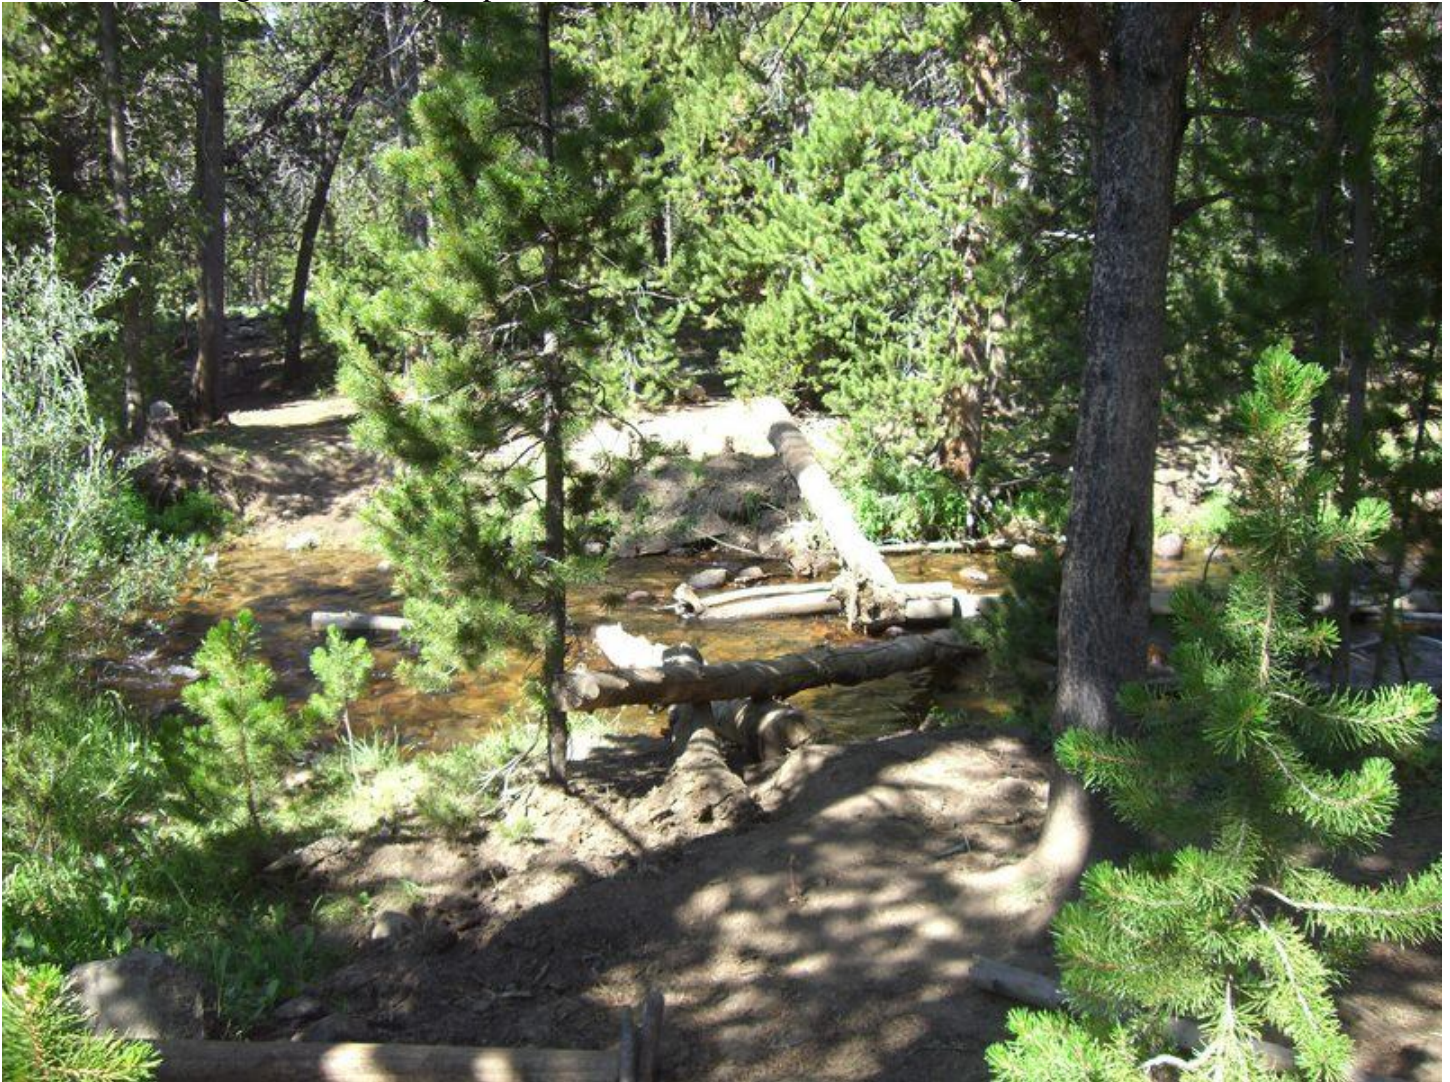
This next photo shows the same spot over the creek following the removal of the bridge.

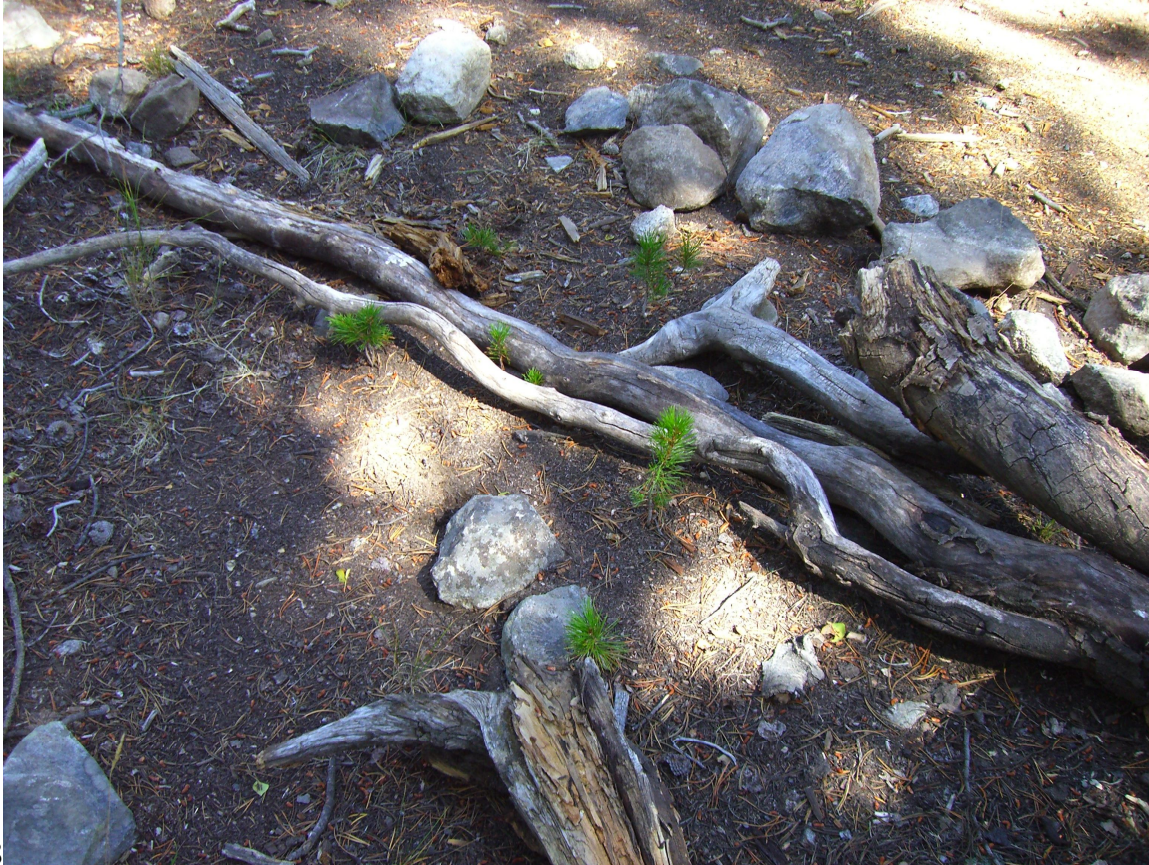
The next photo shows a close up of a trail rehabilitation showing new trees sprouting on what was a highly used main trail – photo taken in September of a spot near Montana Kitchen.

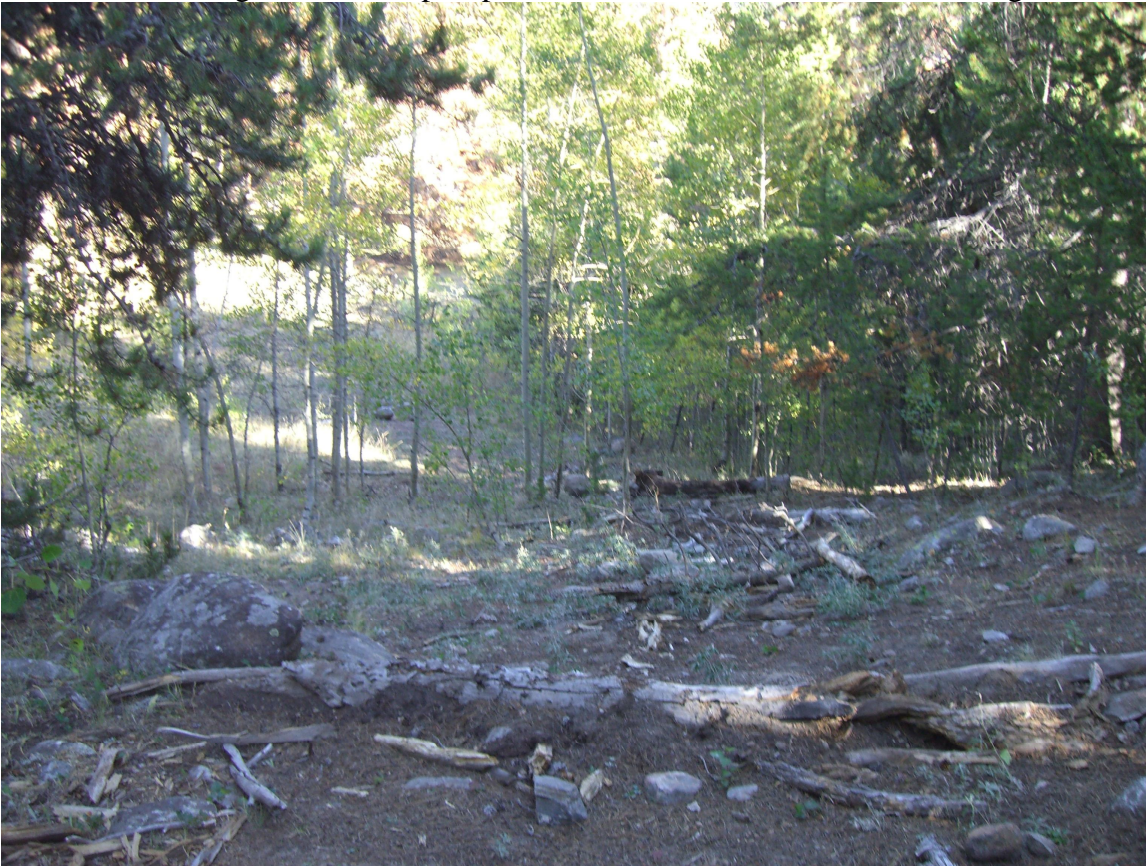
The next photo shows an example of our water barring technique. This particular water bar was created on the main (snake) trail – and one of 50 or more that were constructed during cleanup.

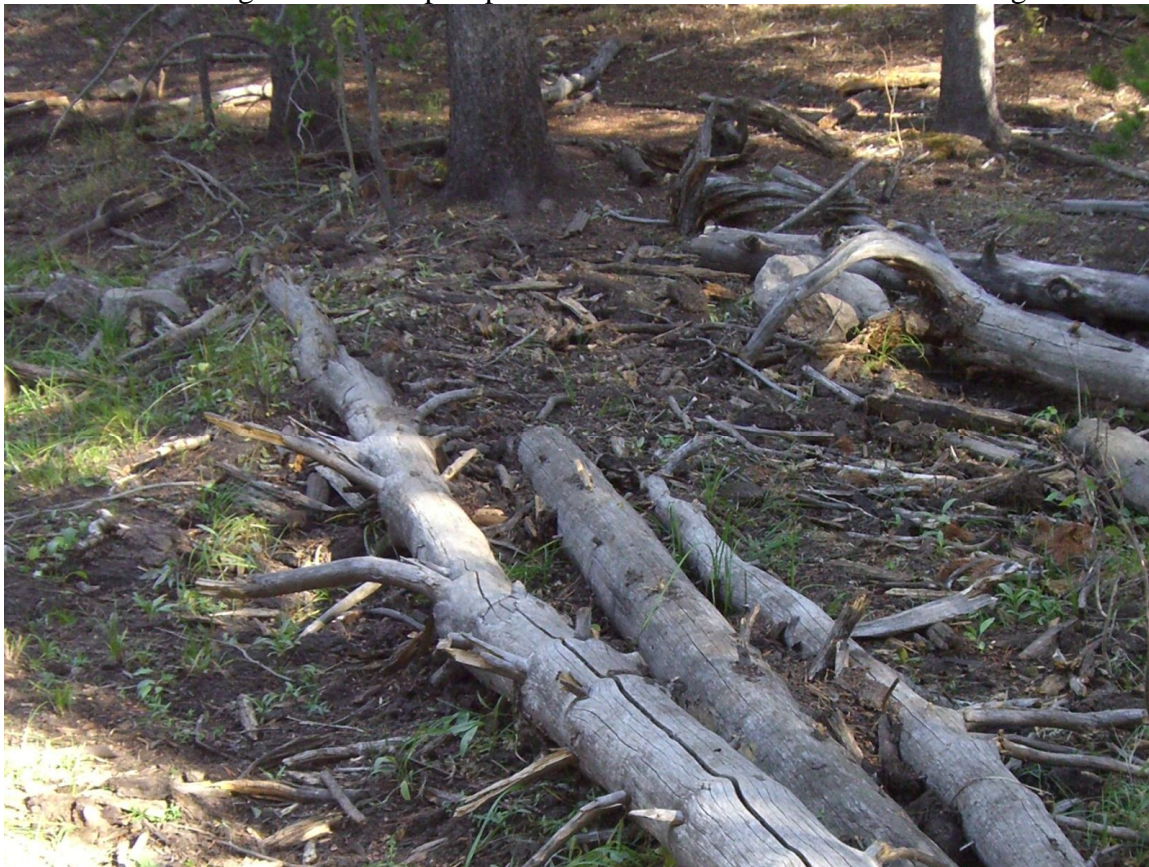
This next photo depicts one of the sections of trail that we rehabilitated to prevent any wheeled access and to strongly discourage human foot traffic as well as large animal traffic. This was once the main trail. The techniques used make it difficult for anyone to utilize the trail and forces all traffic (human or animal) to disperse.
